Manhole Inspection Summary

Manhole # S35Y1_017MH

Location Address: **3916 Potee St**

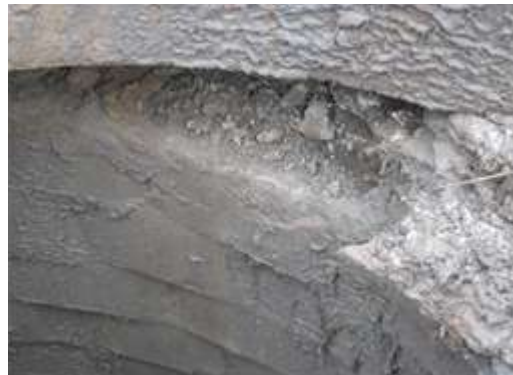
Defect 2

Infiltration: ☐ None ☐ Joint ☐ Cracks ☐ Mortar ☐ Roots ☒ **Wall**

Frame-Chimney joint.

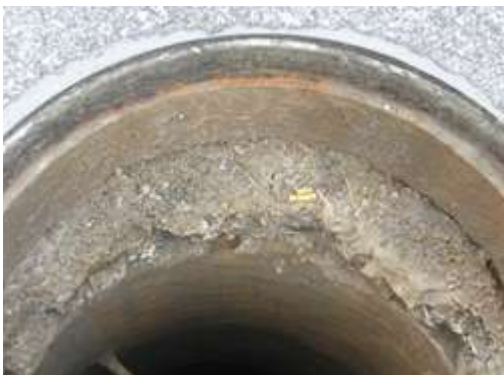
Defect 1

Frame Offset: **4** (in.) Condition: ☒ Sound ☐ Cracked ☐ Leaks

Frame offset

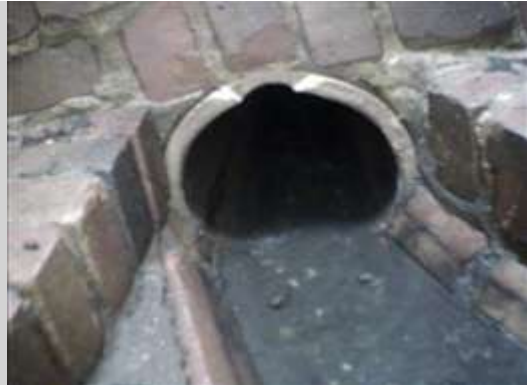
12 O'Clock Outflow

Pipe Height: **8.4** (in.) Rod and Bar (Angled)
Pipe Material: **Clay** ☐ Pipe Lined
Invert Depth: **11.68** (ft.) Flow Characteristics: **None**
Deposits: ☐ None ☒ **Mud** ☐ Sludge ☐ Debris ☐ Grease
Silt Depth: **3** (in.) Deposits Extent: **Medium**
Infiltration: **None** Pipe Seal Cond: **Sound**

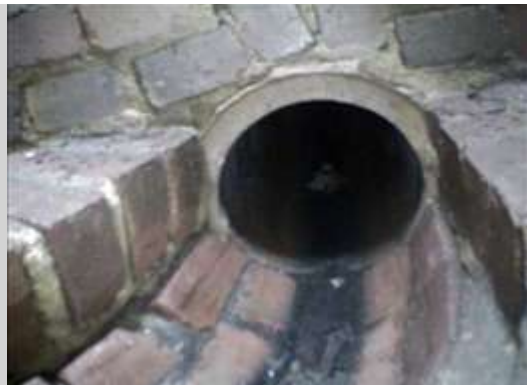
3 O'Clock Inflow

Pipe Height: **8.4** (in.) Rod and Bar (Angled)
Pipe Material: **Clay** ☐ Pipe Lined
Invert Depth: **11.72** (ft.) Flow Characteristics: **None**
Deposits: ☒ None ☐ Mud ☐ Sludge ☐ Debris ☐ Grease
Silt Depth: (in.) Deposits Extent:
Infiltration: **None** Pipe Seal Cond: **Sound**

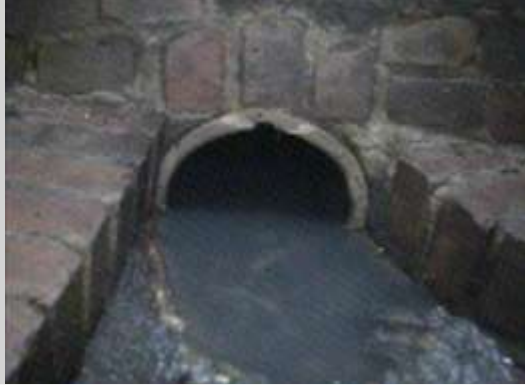
9 O'Clock Inflow

Invert Depth: **11.90** (ft.) Flow Characteristics: **Slow**
